**DEPARTMENT OF TRANSPORTATION**

Contract #: 04-0120F4Cty: SF/ALA Rte: 80 PM: 13.2/13.9File #: 69.28**WELDING INSPECTION REPORT****Resident Engineer:**Siegenthaler, Peter**Address:** 333 Burma Road**City:** Oakland, CA 94607**Report No:** WIR-023836**Date Inspected:** 28-Apr-2011**Project Name:** SAS Superstructure**OSM Arrival Time:** 700**Prime Contractor:** American Bridge/Fluor Enterprises, a JV**OSM Departure Time:** 1900**Contractor:** Zhenhua Port Machinery Company, Ltd (ZPMC), Changxing Island **Location:** Shanghai, China**CWI Name:** An Qing Xiang**CWI Present:** Yes No**Inspected CWI report:** Yes No N/A**Rod Oven in Use:** Yes No N/A**Electrode to specification:** Yes No N/A**Weld Procedures Followed:** Yes No N/A**Qualified Welders:** Yes No N/A**Verified Joint Fit-up:** Yes No N/A**Approved Drawings:** Yes No N/A**Approved WPS:** Yes No N/A**Delayed / Cancelled:** Yes No N/A**Bridge No:** 34-0006**Component:** OBG Components**Summary of Items Observed:**

Outside Yard – OBG Trial Assembly

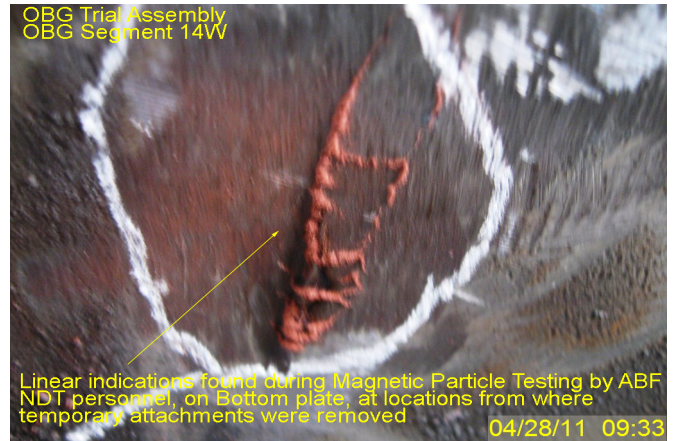
This QA Inspector observed ABF qualified NDT personnel perform Magnetic Particle Testing on Bottom Plates of OBG Segment 14W, at locations from where temporary attachments were removed. The Bottom Plates were identified as BP3087 ~ BP3094 between Panel point 125 to Panel point 128.7. Linear indications were found on some locations. This QA Inspector informed ZPMC CWI identified as An Qing Xiang of the issue. An Qing Xiang informed this QA that the indications shall be removed in a manner compliant with the contract documents prior to welding. See attached pictures.
